**Flood Control Project Maintenance  
Levee Inspections**

**Fall 2009 Levee Maintenance Deficiency Summary Report**

**Sutter Maintenance Yard Maintenance Area 0016**

**Levee Inspection Report By Mile - Fall 2009**

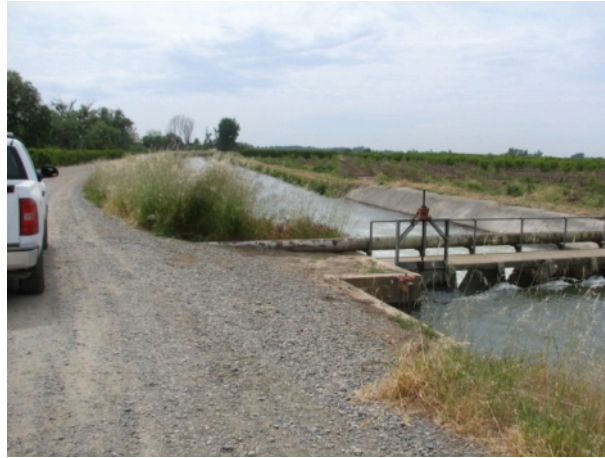
cathom\_20090924\_3.jpg

Levee Mile Report Line	4
Start Levee Mile	2.85
End Levee Mile	3.08
Location	Land Side
Category	Earthen Levee
Item	Encroachments

AG ditch land side slope and toe.
